Accident to the WACO - YMF5 registered F-GYMF

on 06 August 2021

at Yvoy-le-Marron (Loir-et-Cher)

Engine shut-down in cruise flight, forced landing, collision with trees then the ground

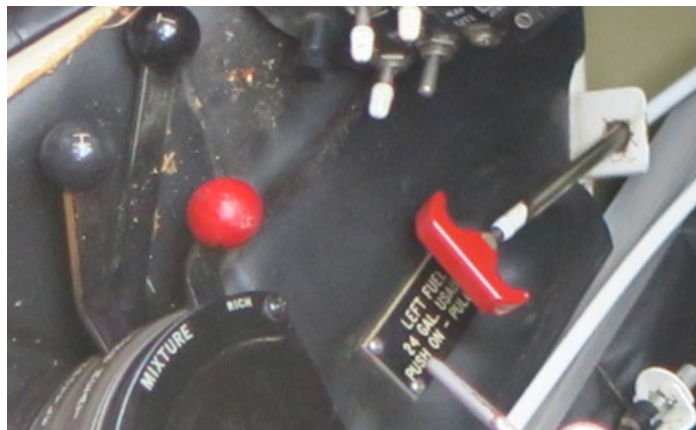
Figure 1: left fuel pull-type control, in closed position

The left-hand tank was under the aeroplane fuselage and was found in a highly damaged condition. Owing to the extent of this damage, it was not possible to estimate the quantity of fuel in this tank at the time of the accident. The left-hand fuel valve control was found pulled out, corresponding to the closed position. Although it slid freely over its full range of travel, significant force was required to move it.

The pilot was on a ferry flight from the aerodrome where the annual maintenance of the aircraft had been performed. During this inspection, in order to work on the right tank, the left-hand fuel tank selector had been closed.

The pilot performed the actions and check-lists during the preparation and during the flight from memory and did not sufficiently check the position of the left tank valve.

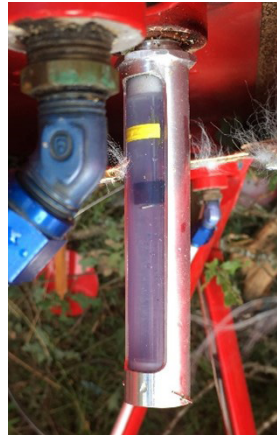
Each tank is equipped with a float-type sight gauge, positioned under the upper wing in the central section of the tank, visible from the cockpit. According to the maintenance manual of the YMF5, the reading of this gauge is reputed to be reliable in level flight. This is not the case on the ground, owing to the aeroplane's attitude. On this gauge, the yellow line corresponds to a quantity of 10 US gal.

Figure 2: fuel level sight gauge

Regarding the gauges of F-GYMF, he believed that the gauge indicator could not be seen when the tank was more than half full. For this reason, if he could not see the indicator, he considered that the fuel quantity was at more than 50% of the capacity.

He recalled that before the engine shut down, he estimated the right gauge at around 20% and the left had not been visible, which he interpreted as an indication of a tank that was at more than half of its capacity. He had not considered these indications to be abnormal given the flight time passed, his knowledge of the aeroplane and the specific features identified.

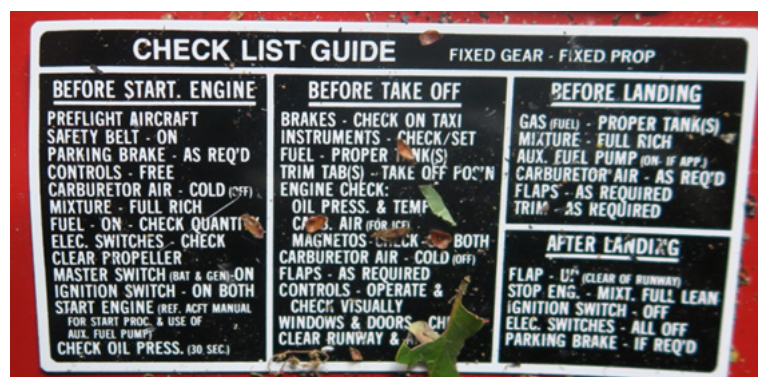
Figure 3: checklist displayed in the cockpit of F-GYMF

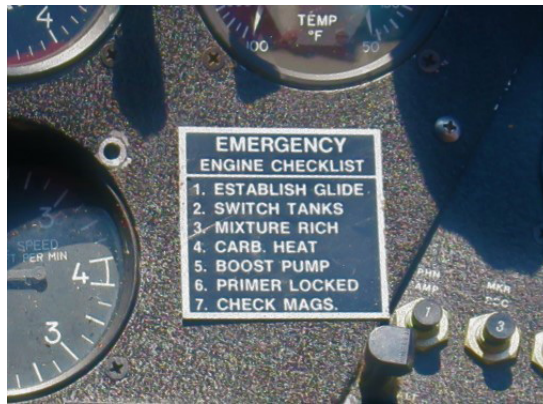
Figure 4: Emergency Engine Checklist plate on board F-GYMF

The pilot performed the actions to restart the engine from memory but forgot to check the position of the fuel valve controls. When he referred to the emergency plate, he realised this omission but felt that he did not have time to attempt a re-start given the height.
